White Paper Report

Implementing Sustainability Strategies for the Abbe Museum's Collections Environment

Grantee Institution: Abbe Museum

BUILDING AIR-BARRIER EVALUATION REPORT—ABBE MUSEUM

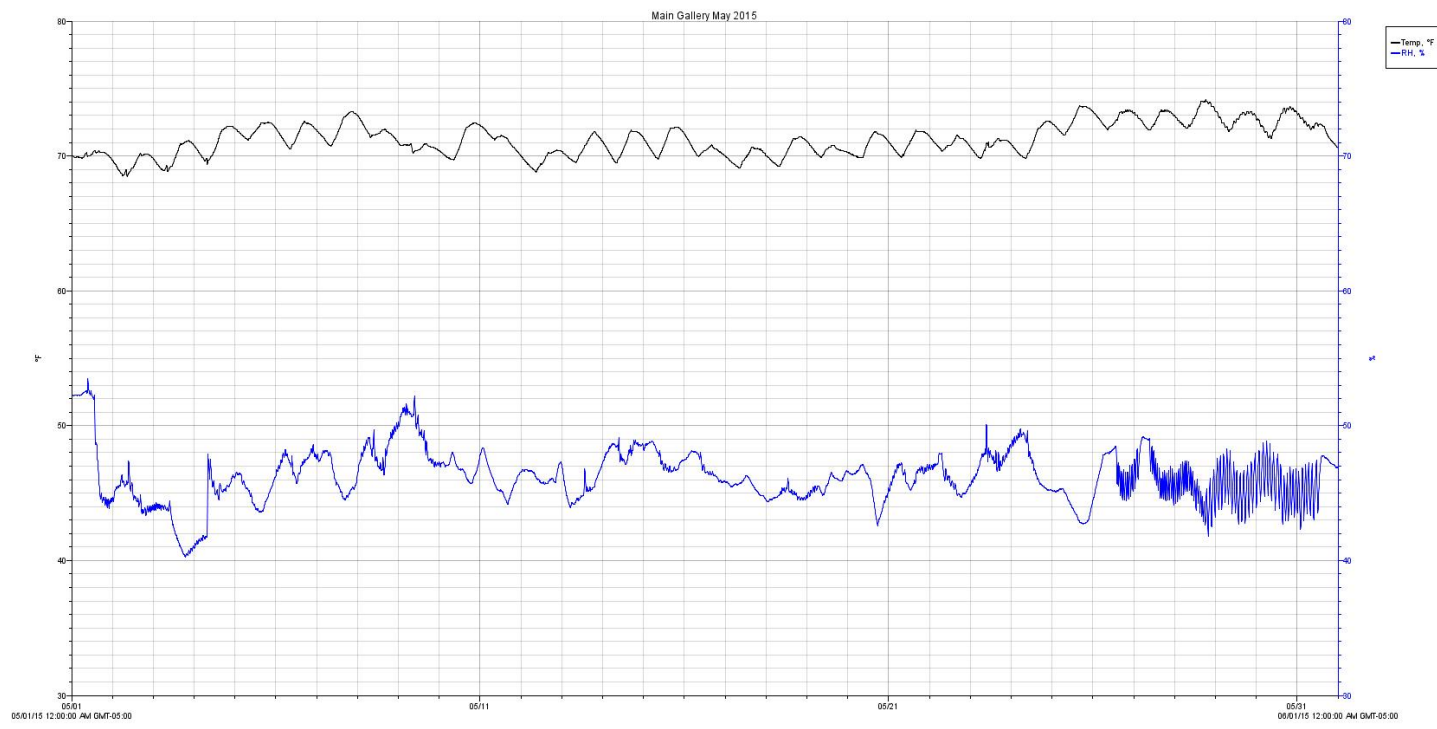
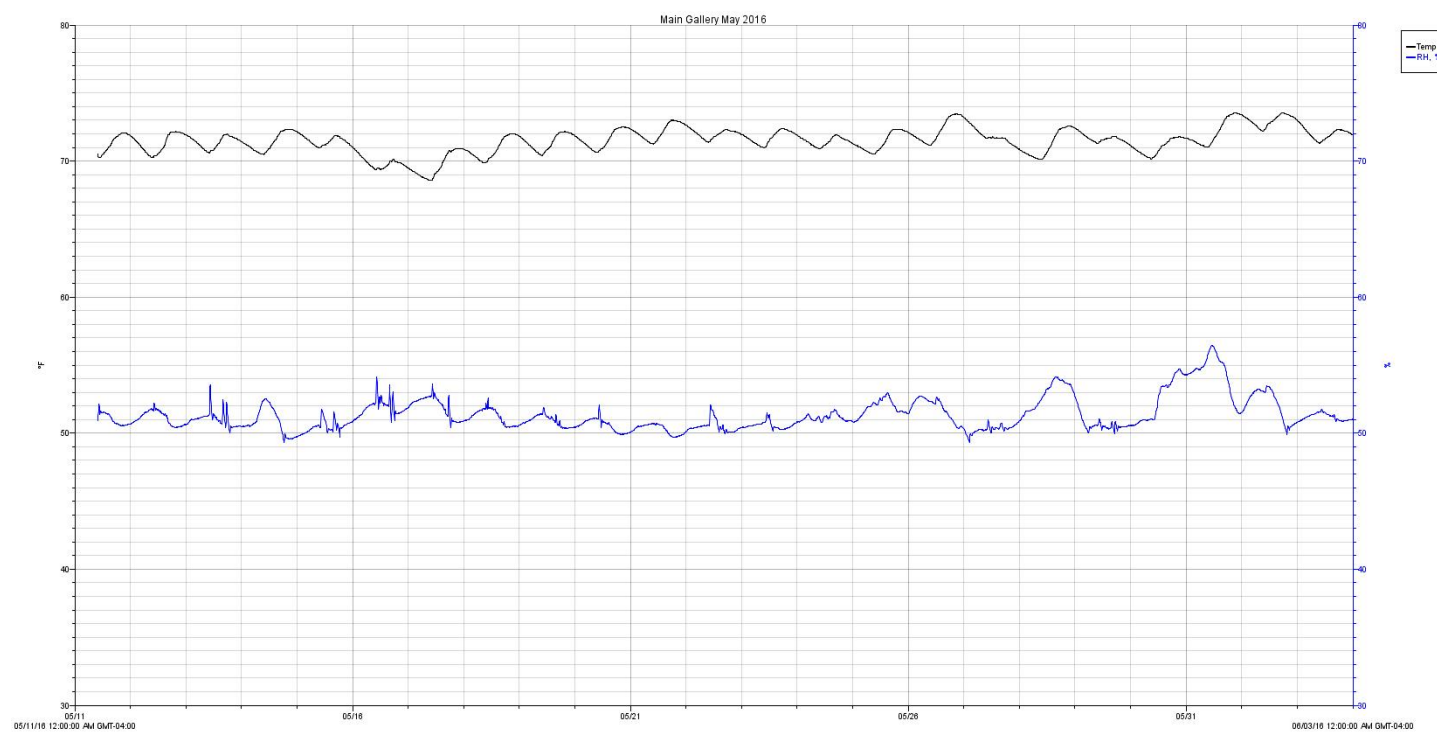
Appendix B: Data Logger Chart Comparisons
Main Gallery, May 2015 (top) compared to May 2016 (bottom), with new dehumidification system.

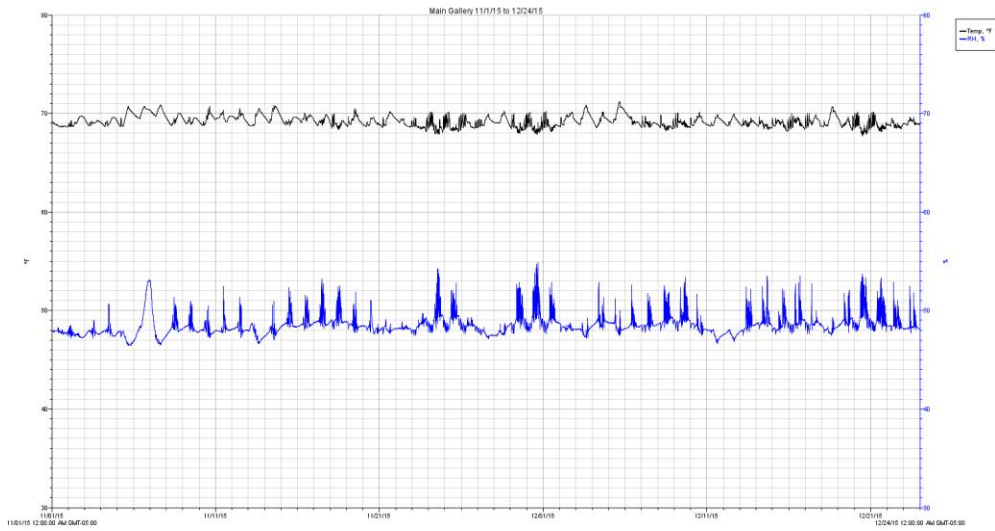
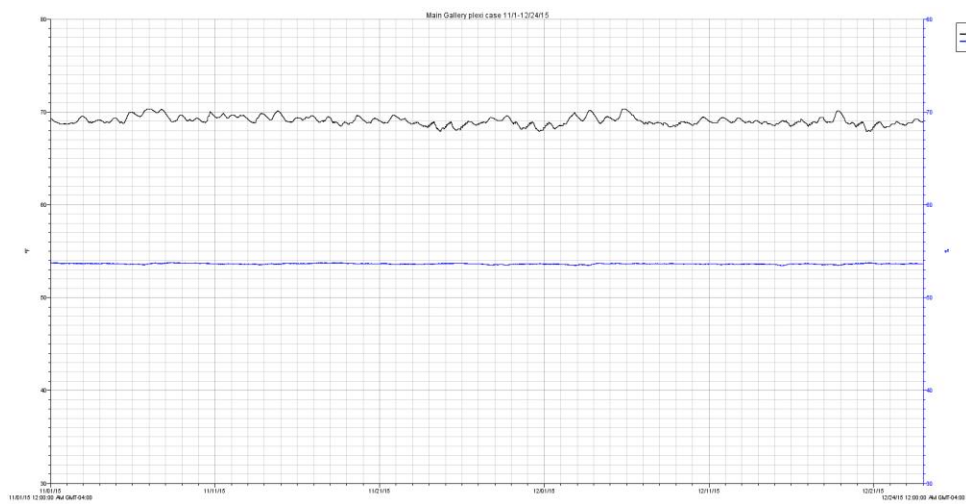
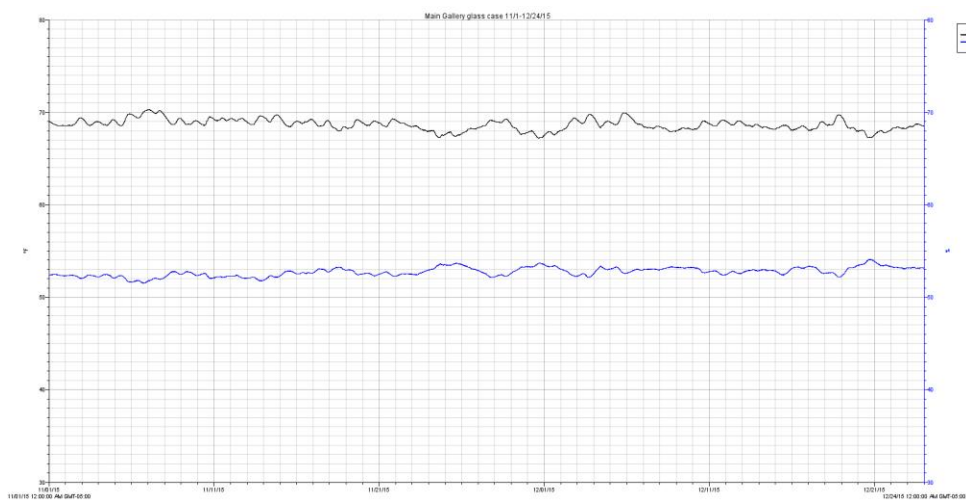
Main Gallery space (top) compared to inside a plexi case (middle) and inside a glass case (bottom) showing buffering effect of display cases.

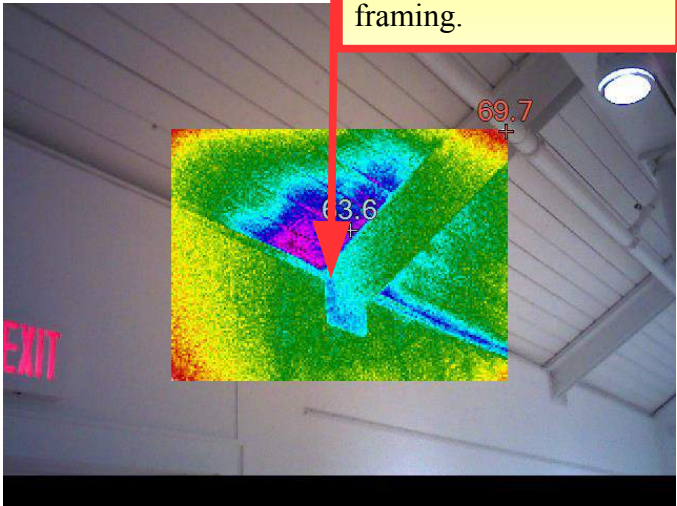
Site of ceiling leak at HVAC supply ductwork. Remove insulation inside of red-line in attic for proper air-sealing.

The eave-leak issue is both an air-barrier and thermal barrier breach. Therefore complete removal of foamboard to pitch change (at red-line left) and removal of fiberglass along reverse slopes (to the right red-line) followed by comprehensive membrane-sealing, air-sealing, and re-insulation should fix the water leaking in, and air leaking out.

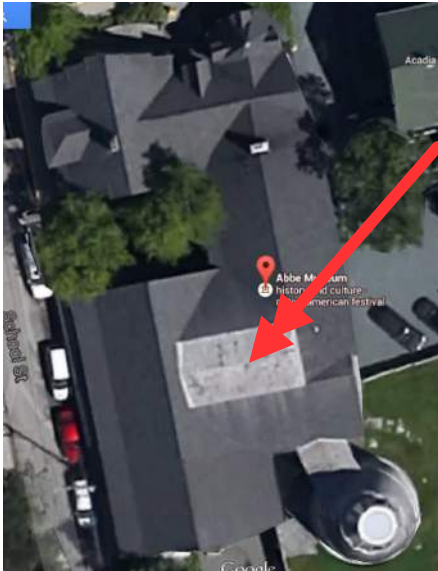
This is the satellite image. Flat roof shows up as whitish.

There is low-pitch (essentially flat) roof above the flat plywood deck as-viewed from the attic. No venting currently occurs out of this roof cavity. The deck is essentially a double collar tie with 2 layers of sandwiched 1/2" plywood. Cutting through both layers—with as large a hole as is structurally-safe, and connecting to the small attic space will relieve the vapor pressure in the attic space immediately above the exhibit room.

Type/ location	Recommendation
Attic	<ol style="list-style-type: none">1. Attic ventilation should be achieved through passive means rather than mechanical. Though no pressure-testing was done in the attic, it is quite possible that the exhaust fan, as it's set up, will pull outside air into the attic via the path of least resistance—or the larger open vents-areas. This means most outside air is pulled in through the soffit venting (east-facing), and likely some inside conditioned air is pulled through the larger holes in the air-barrier (chimney chase, kneewall spaces of original building).2. Unfortunately current attic ventilation, even with the exhaust fan doesn't likely pull enough air from the problem area (over the exhibit hall), mainly because there's no substantial supply of air to feed the exhaust fan.3. Ideally passive attic ventilation is designed to allow for a greater area of open venting down low throughout the attic, and a lesser amount at the very top of the attic. In this case the bottommost venting occurs in spots around the roof...some places unintentionally. While the uppermost venting occurs at the east eaves.4. Creating ventilation above the problem area is the ideal solution.5. Cut holes through the flat plywood decking/framing at the top of the attic space over the exhibit hall to allow airflow into roof cavities. Then either engineer ridge venting at the south-facing section of east/west ridge, or engineer/install a roof vent, built up through a curb to allow proper sealing with existing rubber roofing.
